**Darren Miller About The House LLC**  
**71 Village Dr.**  
**Basking Ridge, NJ 07920**  
**(973) 252-1160**

Inspection No: 201510-04197      Inspector: Darren F. Miller

Inspection Date: 10/17/2015

Dwelling: XX Xxxxx Street  
XXXXXXXX, NJ

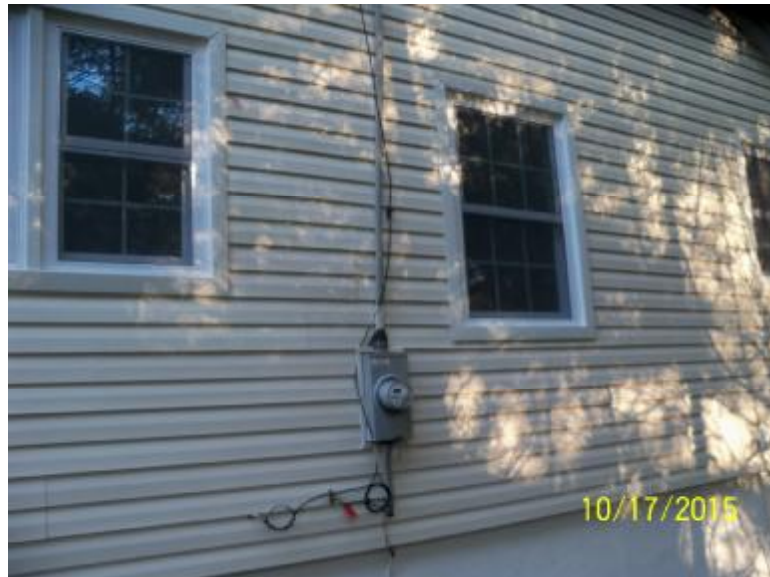
**Figure 1. Overhead electrical service cables are too close to operable windows. See section 1110 below.**

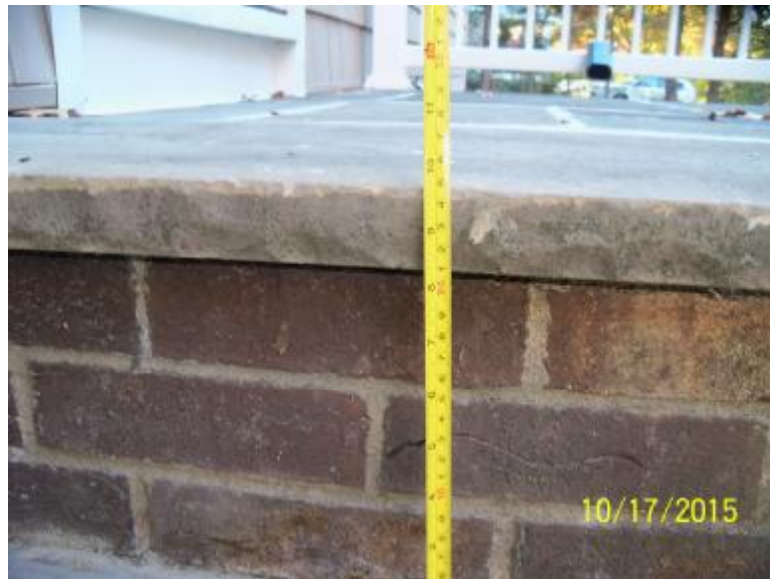
**Figure 2. 9 1/2" top riser.**

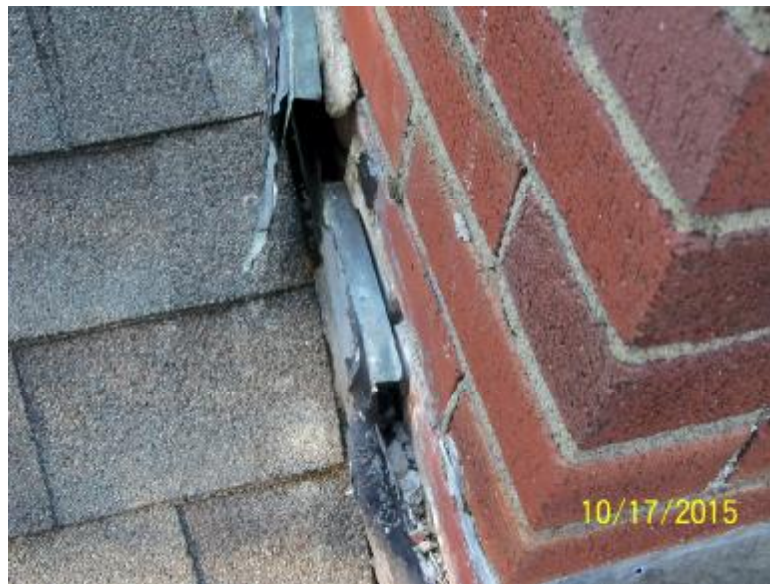
**Figure 3. Large gaps, loose flashing at chimney.**

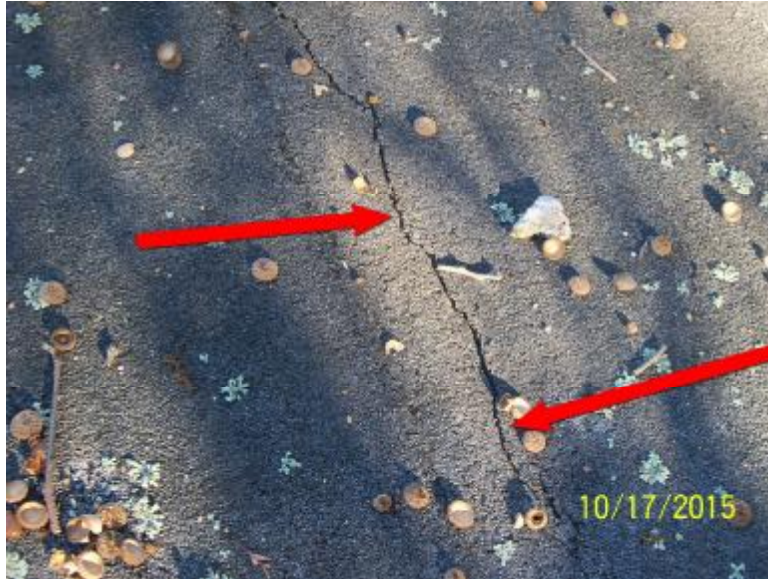
**Figure 4. Cracked rolled roof material.**

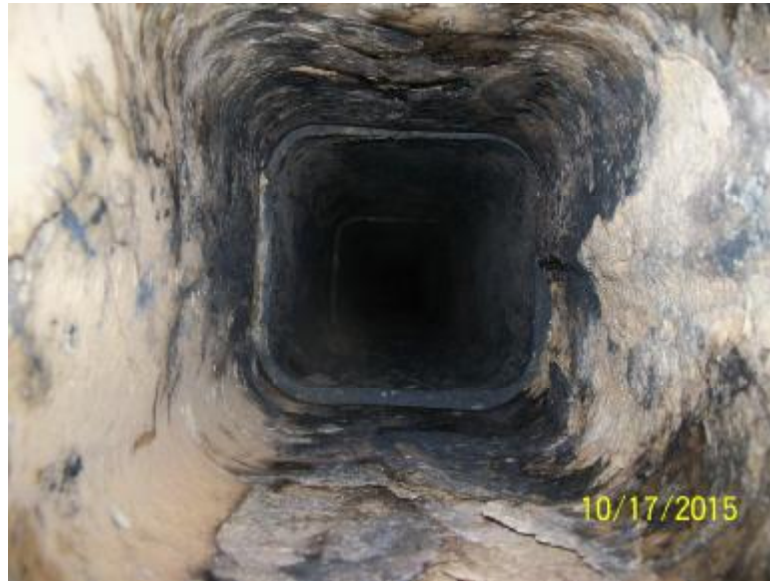
**Fire/Health/Safety.** Terra cotta.

**Flue liner is deteriorated, this is a health concern.** Recommend repairs/re-lining by licensed chimney contractor prior to close.

**Figure 5. Deteriorated liner.**

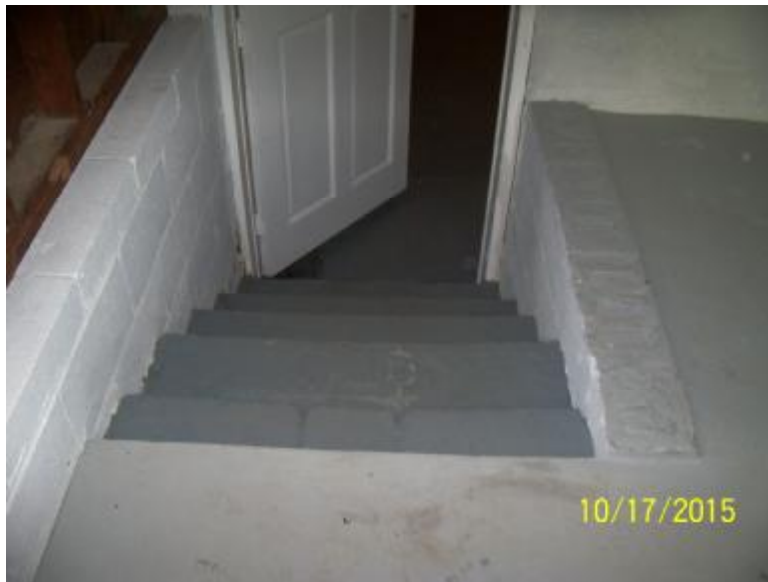
1515	Ceiling	Drywall.
1516	Electrical	<b>Fire/Health/Safety. No GFCI protection present</b> , suggest installing GFCI protected receptacles for safety. See section 1806 for additional information.
1517	Garage Comments	<b>Fire/Health/Safety. The steps to the basement are not uniform; this is a safety concern (possible trip hazard).</b> No difference of 3/8 inch or more is allowed between heights of risers. Several methods of repairs are available; you should consult with a licensed contractor for options & cost estimates prior to close. <b>The guard &amp; handrails are missing at the steps, which is a safety concern.</b> Whenever there are 4 or more risers in a set of steps or the landing is more than 30 inches above the floor or grade, rails are required. Proper guard & handrails should be installed for safety.

**Figure 6. Missing hand and guardrails.**

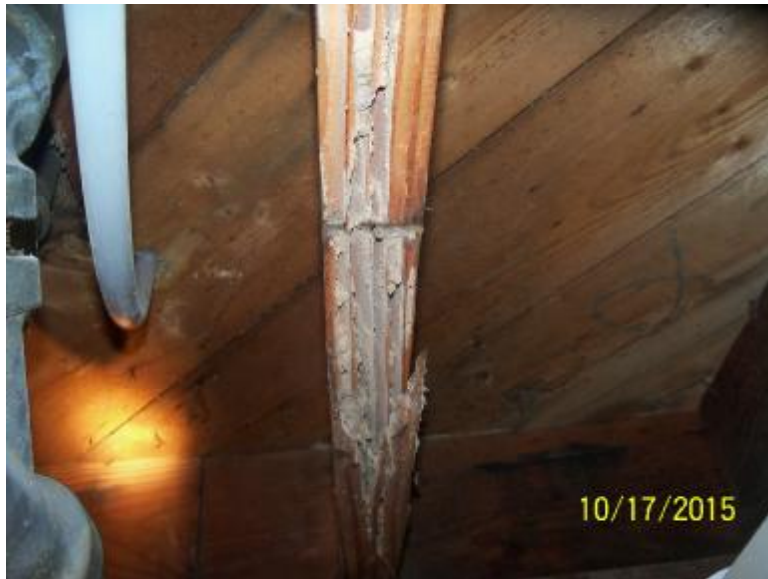
**Figure 7. Termite damaged joist. See section 1607 below.**

- 1607 Joists Defect. Conventional wood framing; 16 inches on center.  
*The joists are secured to the header behind the chimney without hangers or ledger board.* Although the structure has withstood the test of time, I recommend installing joist hangers where missing for added support.  
*There is termite and water damaged joists and box beams at the front and rear;* have a qualified contractor make the proper repairs.  
 While he's on site, have him check on the previously repaired/sistered joists.

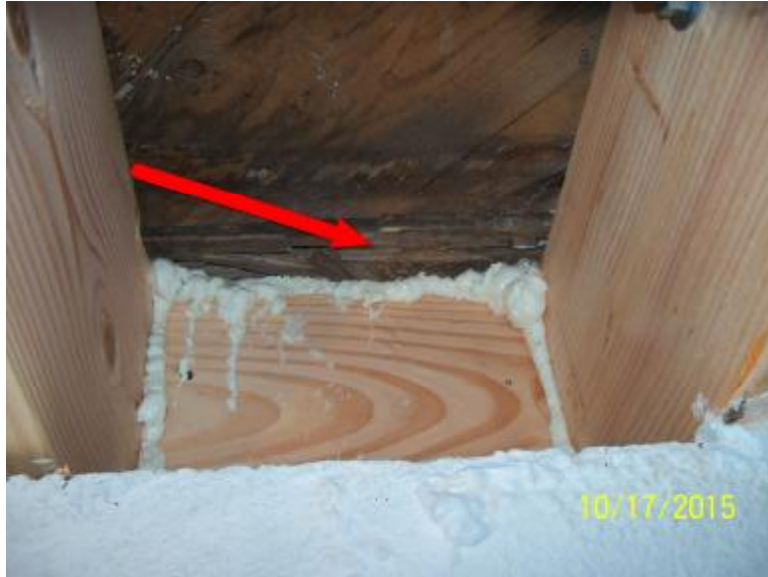
**Figure 8. Front section of house, under the main entry. Note the water damaged wood that was covered with new wood.**

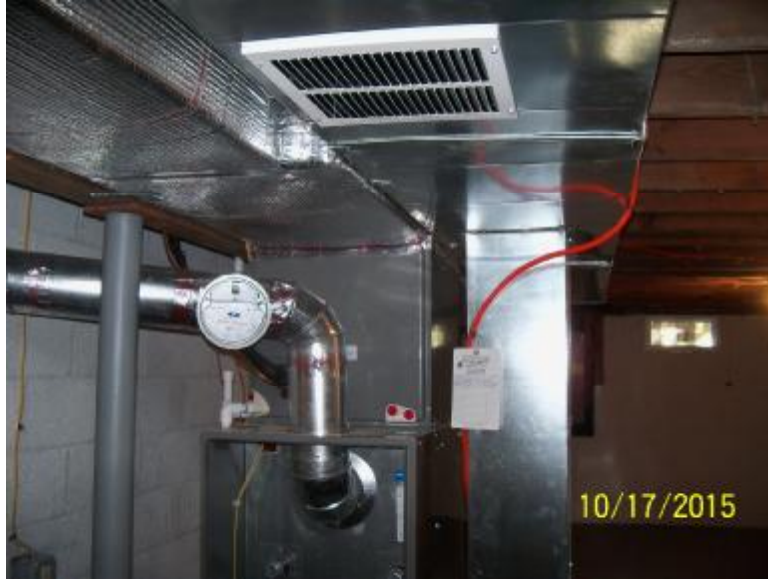
- 1906      Distribution/Ducts      **Fire/Health/Safety.** Ducts/Registers.  
 The filter is located at the unit.  
 Over time, dust/dirt will build-up inside ducts. As every person has a different level of resistance to dust, a wise environmental hygiene investment would be to have the existing ducts cleaned. Consulting with seller about filter change rate and if the ducts have been recently cleaned may help in determining your course of action.  
**A cold air return intake observed within 10 feet of an appliance vent,** which may result in back-drafting and mixing of combustion by-products with interior circulation air. This is a safety concern that requires immediate repairs.

**Figure 9. Return air grill within 10 feet of the barometric damper.**

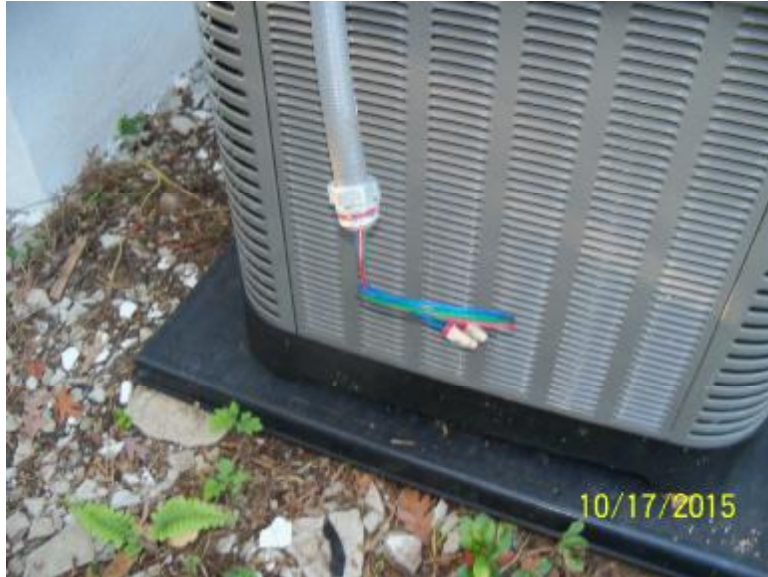
Step #	Component	Comments
2101	Air Conditioning	Defect. Electric; Split system. The condenser is located at the rear. The evaporator coil and air handler are built in as part of the furnace. The unit is manufactured by Rheem. <i>Electrical disconnect is provided near this unit for safety; however, the electrical cable is not connected to the condenser.</i> As of time of inspection, the A/C could not be operated.

**Figure 10. Cable is not connected to the AC unit.**

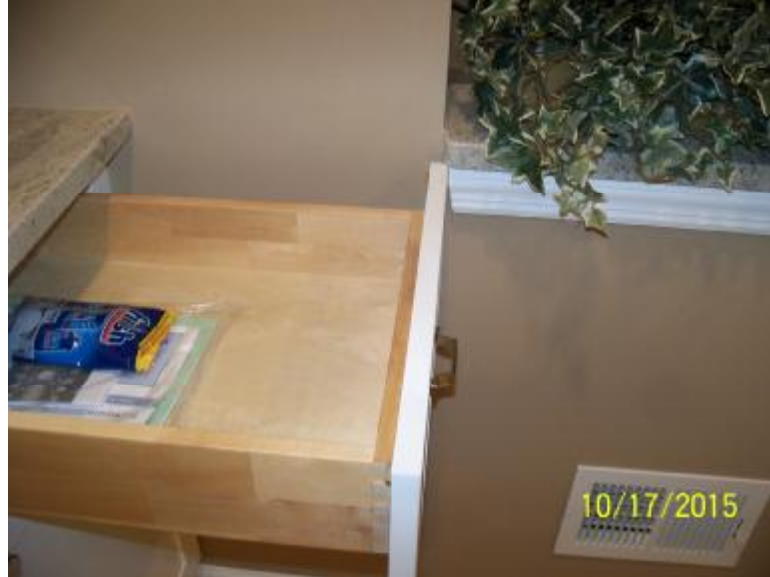
Step #	Component	Comments
2301	Floor	Ceramic tile. <i>The kitchen floor is sloped; using a laser, the floor is 1 inch out of level.</i>
2302	Walls	Serviceable. Paint.
2303	Ceiling	Serviceable. Paint.
2304	Doors	Serviceable.
2305	Windows	Serviceable.
2306	Electrical	Serviceable. Ground fault circuit interrupter provided for safety. The device was tested with a 'Sure-Test' electrical tester and was operational.
2307	Cabinets	Defect. <i>The drawer to the right of the dishwasher hits the cheek wall; repairs are needed for use of drawer. The drawer closet to the basement door is warped.</i>

**Figure 11. Oops!**

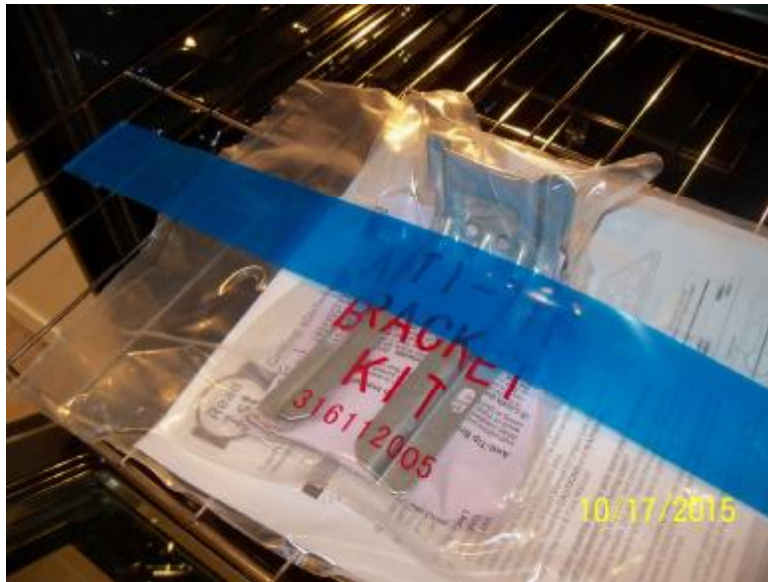
2311	Trap/Drain/Supply	Serviceable. No leaks observed at the time of the inspection.
2312	Disposals	None.
2313	Dishwasher(s)	Serviceable. Make: Frigidaire. The dishwasher was operational at the time of inspection. Dishwashers most commonly fail internally at the pump, motor or seals. Inspectors do not disassemble these units to inspect these components. My inspection is limited to operating the unit on the 'normal wash' cycle only. I recommend you operate this unit prior to closing. No leaks observed.
2314	Water Filter/Heater	None.
2315	Stove/Cook Top	Serviceable. Electric. Make: Frigidaire. The electrical stove/range elements were tested at the time of inspection and functioned properly. These can fail at any time without warning. No warranty, guarantee, or certification is given as to future failure.
2316	Ovens	<b>Fire/Health/Safety.</b> Electric. The upper and lower electric oven elements were tested at the time of inspection and functioned properly. These can fail at any time without warning. No warranty, guarantee, or certification is given as to future failures. Cooktop and oven is the same unit. <b>The oven is missing an anti-tip device; install as required for safety.</b>

**Figure 12. The anti-tip bracket was left inside the oven.**

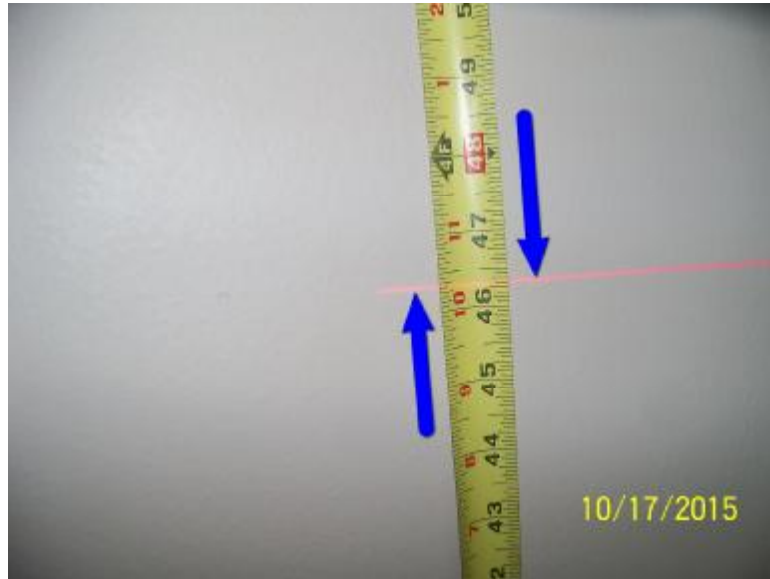
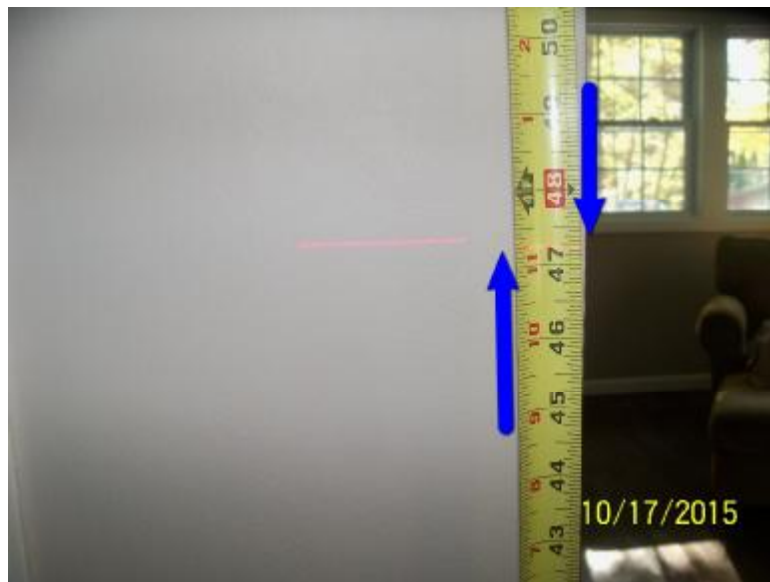
Step #	Component	Comments
2601	Floors	Wood; Ceramic tile. No shoe molding present; gaps at base present. <i>The living room/reading area floors are out of level by 1 inch. This was determined using a laser.</i>

**Figure 13. 46 1/4 inches.**

**Figure 14. 47 1/4 inches.**
