**About The House**  
**71 Village Drive**  
**Basking Ridge, NJ 07920**  
**(973) 252-1160**

1005	Levels	2 story structure.
1006	Estimated Age	This structure is approximately 100 years of age. Age should be confirmed by seller.
1007	Weather Conditions	Clear; Cool. Temperature at the time of inspection was approximately 50-55 degrees.
1008	Type of Inspection(s)	General home inspection; Radon testing; WDI (wood destroying insects) inspection. (See separate NPMA-33 form for WDI results).
1009	Start/Stop Time	Saturday 11/5- Inspection started at 8:25 AM. Inspection was completed at 12:30 PM. I returned Wednesday to pick up radon and check fixtures due to water being off during original inspection. Wednesday 11/9 Inspection started 4:05 PM. Inspection as completed 4:40 PM.

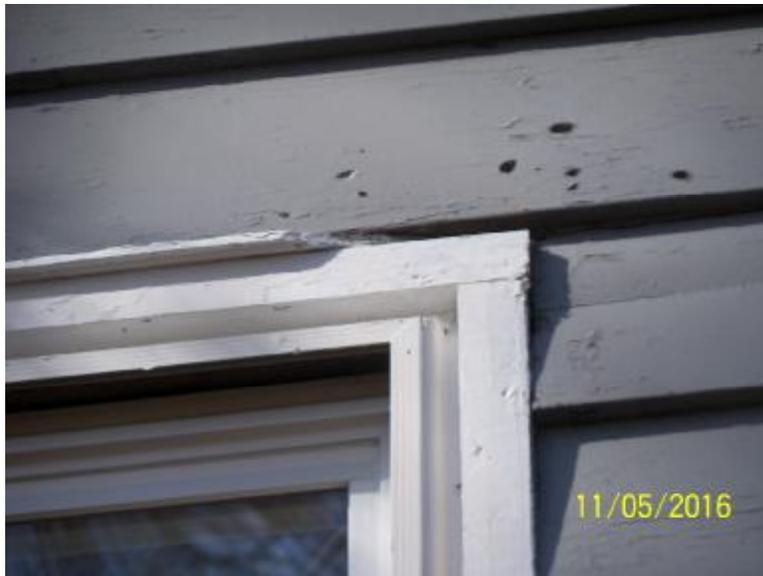
- 1105 Window & Frames Defect. Vinyl frame; Wood frame; Aluminum frame; Casement; Double hung; Sliding; Double glazed insulated.  
*Old storm window frames were left in place; remove them as they may prevent water from draining.*  
*Wood deterioration is present at left & right side upper & right side lower windows. Repair as needed.*  
*The lower left side front window frame is rotted and there is an open gap at the top. Replace the window.*  
*The left side rear window has a damaged drip cap; replace the drip cap to prevent water entry in, behind the window head.*  
 Double glazed insulated windows (and possibly doors) observed. I am unable to determine if all insulated windows & doors in this property are completely intact and without broken seals. Conditions such as temperature, humidity and lighting limits the ability of the inspector to review these windows for broken seals. For more information on the condition of these windows, consult the seller prior to closing.

**Figure 1. Damaged drip cap; also note the woodpecker damage.**

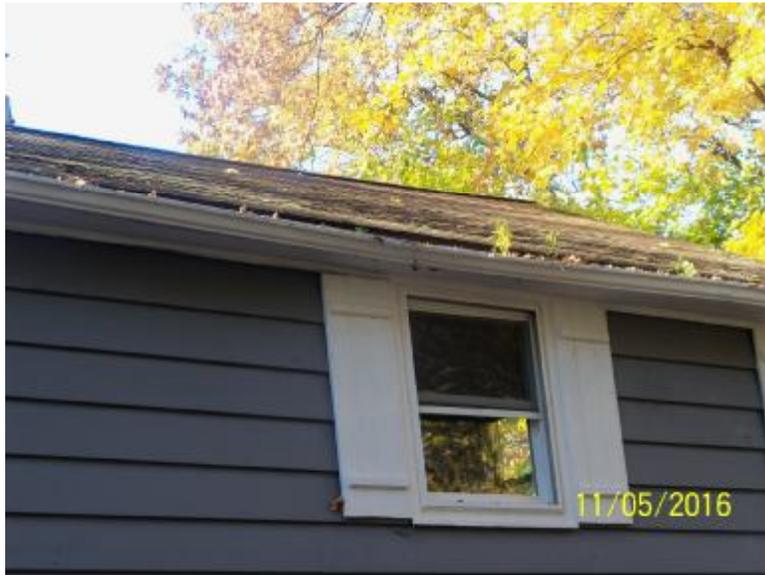
1107	Gutter/Downspout	<p>Defect. Aluminum.</p> <p><i>The gutters are sagging, improperly pitched at right side front.</i></p> <p>Recommend repairs for proper operation.</p> <p><i>Missing downspouts observed at right side front &amp; center rear.</i> Install downspouts to ensure proper drainage away from the foundation.</p> <p>The gutters need to be cleaned out now &amp; as a part of a normal maintenance routine to ensure proper drainage.</p> <p>The primary function of gutters is to keep excessive water away from foundation. Properly functioning gutters will result in a drier basement and will lessen foundation deterioration. End caps, splices and downspouts connections are prone to leakage. Caulking/sealing these joints as part of yearly maintenance will prevent water deterioration in the future.</p>
------	------------------	---

**Figure 2. Sagging gutter at front right side. Also note the leaves that are clogging the gutters.**

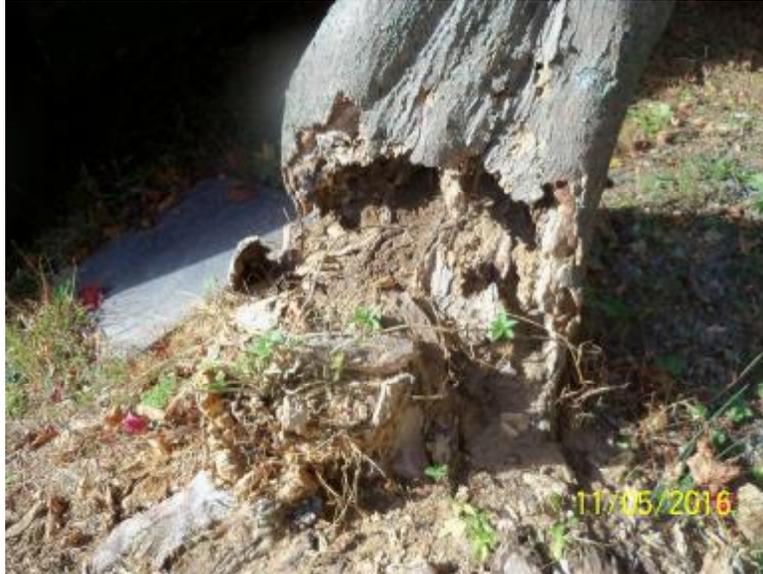
- 1115 Lot/Grade  
Drainage Defect. Minor slope.  
*Re-grading or adding a drainage system is needed at the lower front to assure all water drains away from the home's foundation at all times. The tree between the driveway and river is dead; it needs to be removed.*

**Figure 3. Remove the dead tree before it falls and injures someone.**

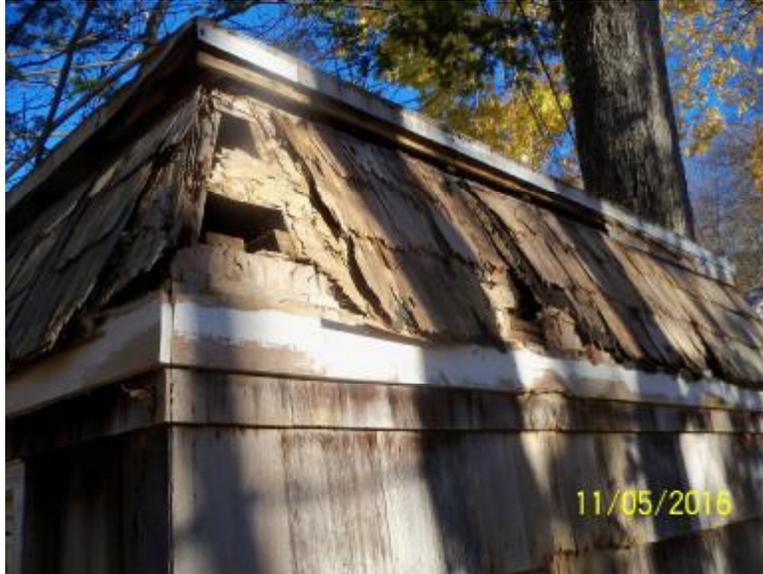
1119	Exterior Comments	Defect. Seal all thru wall penetrations. This will help prevent water & pest entry. Not all window & door flashings are visible; due to type of construction, flashings are covered with siding & trim and cannot be viewed. <i>The rear shed is rotted, damaged. Have the seller remove it.</i>
------	----------------------	--

Figure 4. Rotted shed.

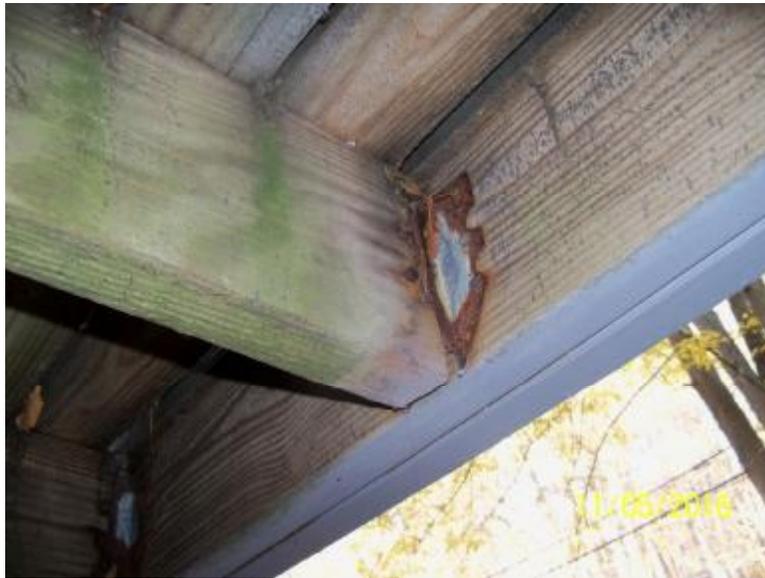
*The joist hangers show signs of rust, deterioration.* It's possible the chemicals from the wood have caused the rusting. To ensure a safe deck system, the hangers should be replaced.

**Figure 5. The bottom of this joist hanger has rusted away.**

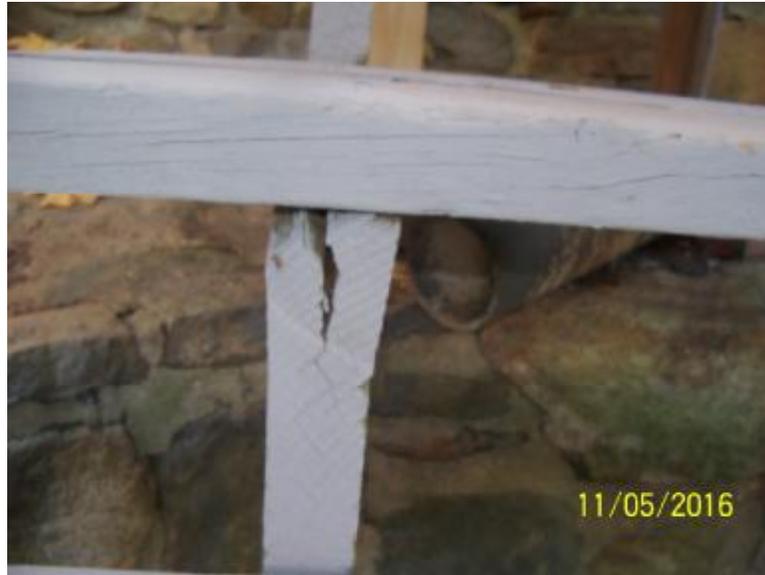
- 1204      Stairs/Steps      **Fire/Health/Safety. Wood.**  
*The bottoms of several support posts have wood rot, deterioration.*  
 Repairs are needed for continued sound support.  
*The stringers have split where the treads are nailed;* this will allow for failure of the stringers or loose treads. Replace the stringers.  
*The depth of the stringer at the riser/tread cut out is 3 inches; this is less than the recommended 5 inches.* This could lead to failure of the stair system. Re-enforce or replace the stringers for safety.  
**The steps have open risers;** this means there is an opening larger than 4 inches. The risers should be 'boxed' in or at the very least install a rail to prevent small children from slipping thru.

**Figure 6. Split stringer where the tread is nailed.**

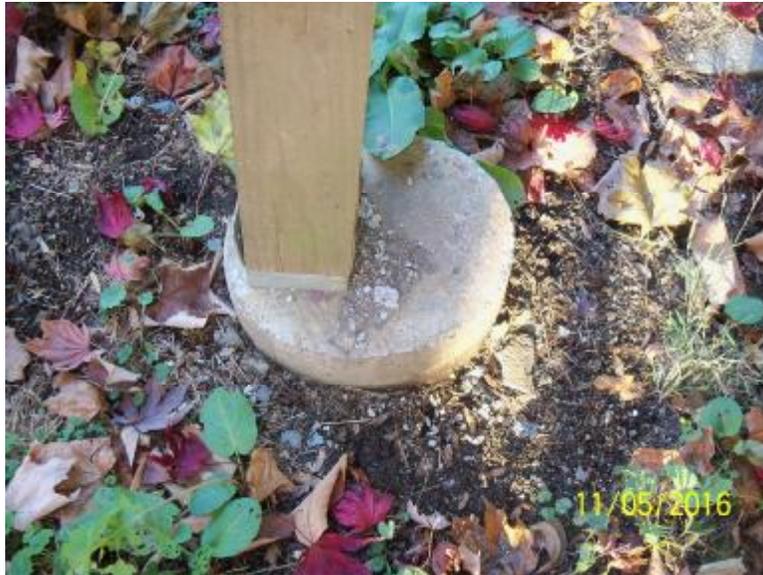
1203.2 Deck/Slab Defect. Wood.  
*The deck is attached to a cantilevered section of the house.* This may be improper and could result in serious problems to the interior floor or wall framing of the house. Your best bet is to have the current set-up reviewed by an architect or structural engineer (prior to expiration of inspection period) to determine if current installation is correct or if repairs can be made.  
*The post footings have eccentric loading.* This means the post is not centered and can cause the footing to move. Repairs are recommended (having the post sit on the center of the footing) to prevent movement and ensure proper support.  
*As best as I can determine, the footings are too small.* The minimum a footing can be is 12 inches. Repairs can be expensive; have a competent carpenter offer an accurate price quote (prior to expiration of inspection period) to replace the footings.

**Figure 7. Eccentric loading on a footing that's too small.**
